# A unique way to repair flat plates

*Coring slabs and bonding new bars in holes corrects structural problem caused by placing top bars too low*

BY LINDSAY M. ANDERSON  
ARCHITECT/STRUCTURAL ENGINEER  
EUGENE P. HOLLAND  
PRESIDENT  
EUGENE HOLLAND & ASSOCIATES, LTD.  
SCHAUMBURG, ILLINOIS

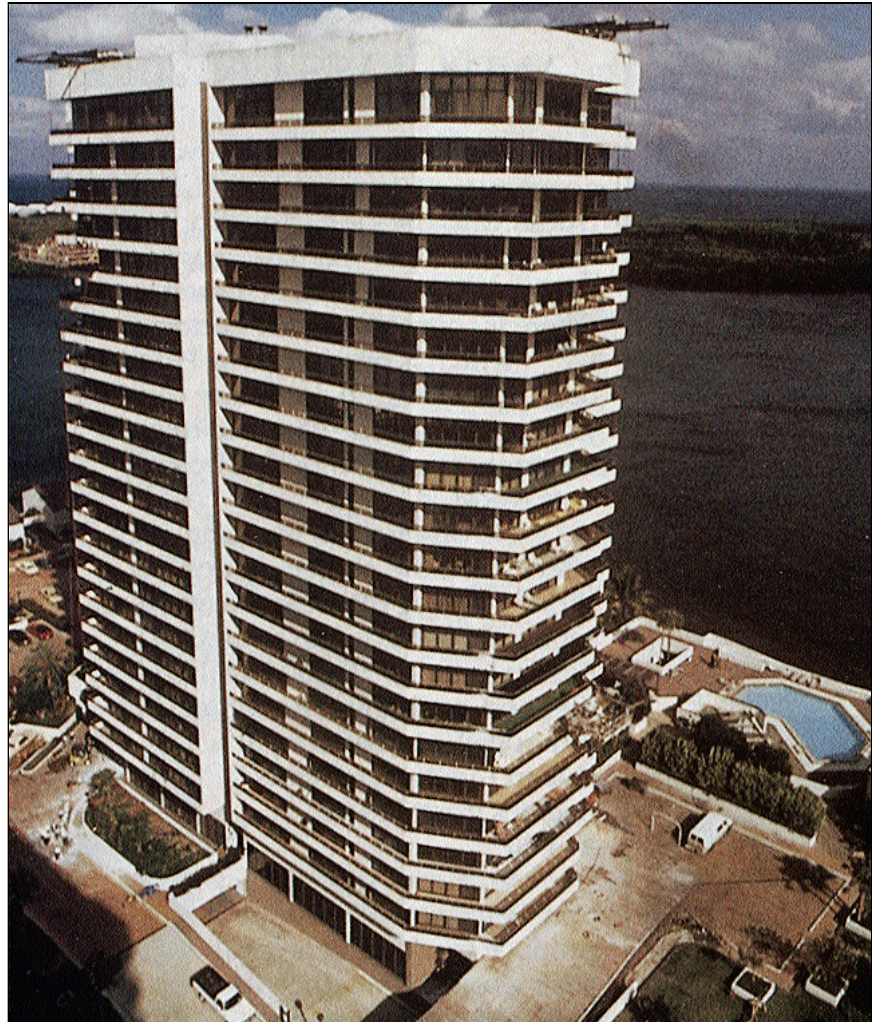
**I**nnovative repair methods used on a South Florida high-rise corrected problems caused by poor construction practices. The 22-story reinforced concrete residential building was completed in 1981. The floor structure consists of a two-way flat plate which is continuous with 8-foot cantilever balconies. The 8½ -inch-thick balconies surround the building perimeter (Figure 1) and were found to be structurally deficient.

The balconies hadn't collapsed but had sagged and cracked. At first building occupants were unhappy about the unsightly cracks but weren't aware that a structural problem existed.

Two engineering firms reviewed the problem and found a major structural defect existed. The top reinforcement was placed too low in the balcony slabs. Drawings called for reinforcement to be 1 inch below the top surface of the concrete. The reinforcement was as much as 3½ inches below the top of concrete.

Figure 1. The 8½ -inch-thick concrete balconies that run around the perimeter of this residential building in Florida had cracked and sagged. The scaffolding for the repair is hung from the roof.

Calculations revealed many of the slabs could barely carry their own weight. The cracking was an expected result of the improperly placed top reinforcement.

The second method of adding reinforcing to the balcony slabs was unique to the repair of flat plates but was chosen as the most effective repair choice. Holes ranging from about 16 to 19 feet long had to be cored into the edge of the slab. New reinforcement then had to be installed and simultaneously bonded into the holes.

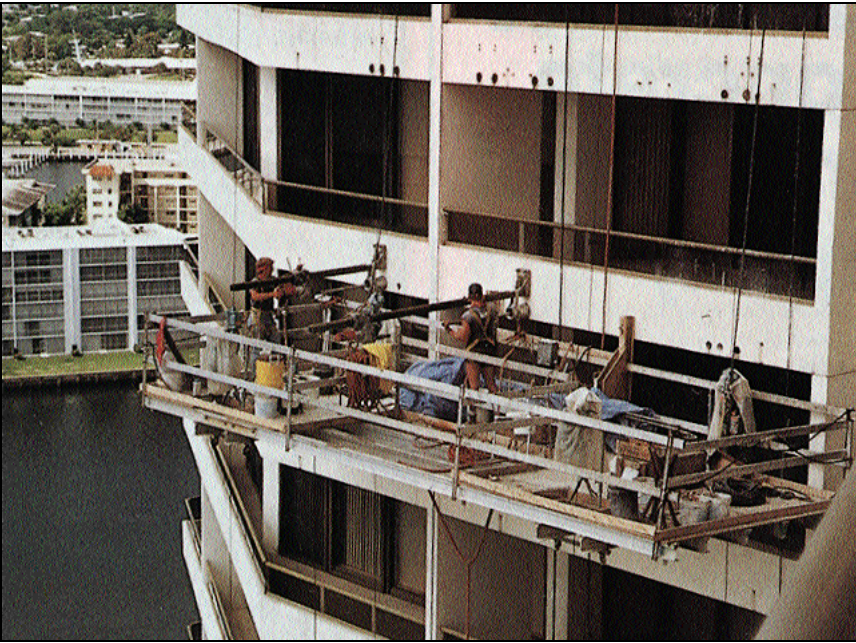
Figure 2. The working platform is big enough for two workers to drill 16- to 19-foot-deep holes into the balconies for adding reinforcement.

Kenyon/Drilcorp used a 10-foot-deep stage set perpendicular to the balcony (Figure 2). The stage was more than 20 feet wide, allowing two workers to drill at the same time. One driller could help the other if necessary.

In general, the stages were supported by four cables hung from support structures at the roof. These support structures consisted of counterweighted aluminum trusses and steel beams set on the roof on bearing plates. No roof anchors were necessary so no repairs were required at the end of the project.

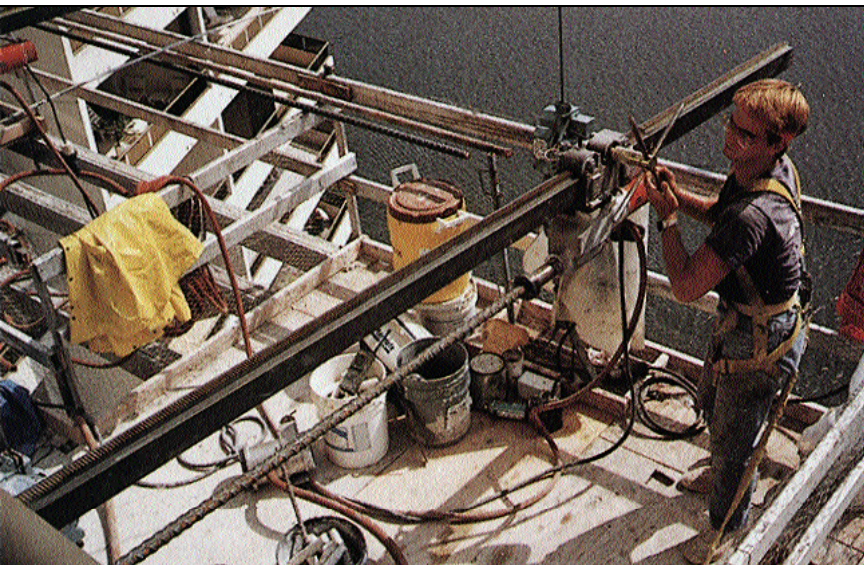
Figure 3. A worker spins the #10 rebar into a hole with a coring drill. The tapered end of the bar rips polyester resin cartridges at the end of the hole, sealing the bar into place.

After coring a hole, workers inserted the polyester resin cartridges and pushed them to the back of the hole with a wooden dowel rod. Then they inserted the new rebar into the hole and attached it to the drilling motor (Figure 3). As the rebar was spun into the hole, its beveled end tore the polyester resin cartridges and mixed the material. Excess resin was collected at the end of the hole.
