# Under fire

*Can tilt-up walls remain standing if the roof burns down? A fire in a Phoenix building proves they can.*

BY JESSE R. WYATT

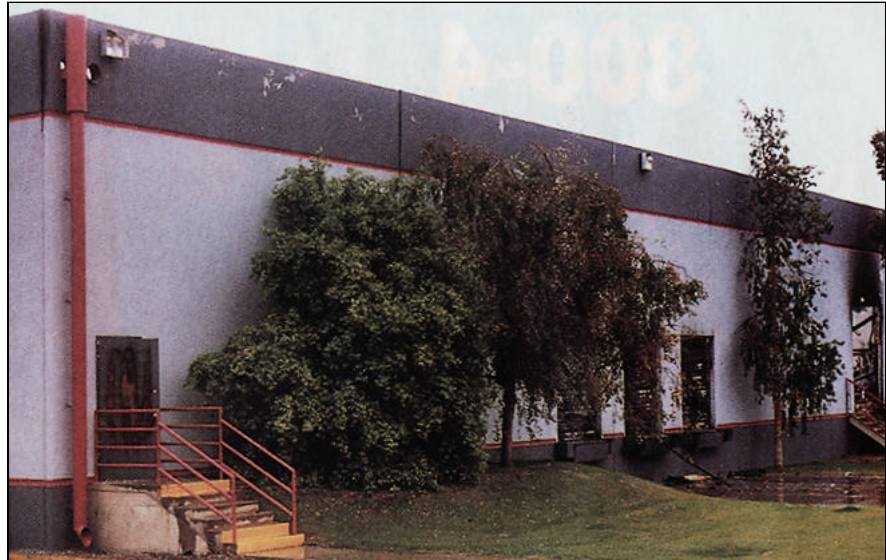
Still standing after a severe fire, the concrete tilt-up walls of this building hide the devastation within (above). However, the fire's heat has deflected some of the panels as much as 8 inches (left).

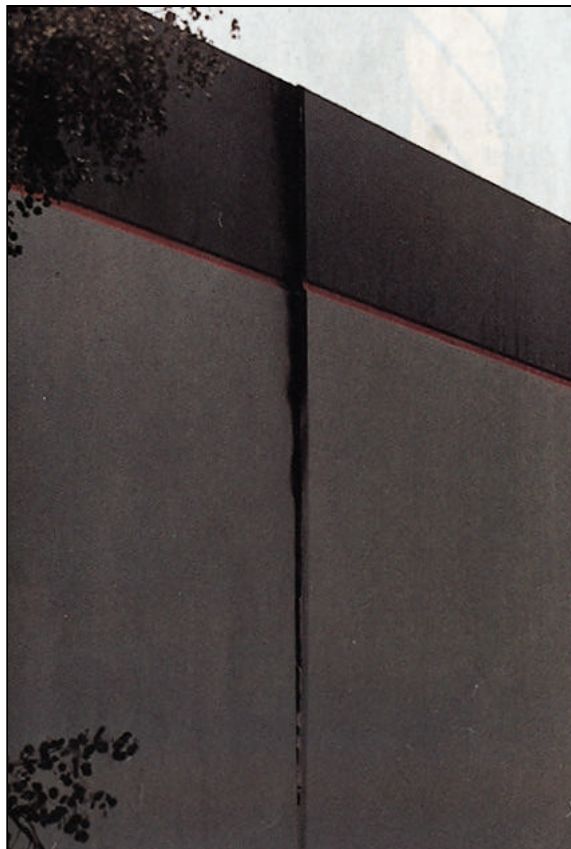
The walls deflected out 6 to 8 inches on the north, west, and south sides of the building. A canopy over the east loading dock limited deflection of the east wall. In a section of the north wall, differential deflection between adjacent panels was about 4 inches. The steel ledger broke at that location and at several other joints.

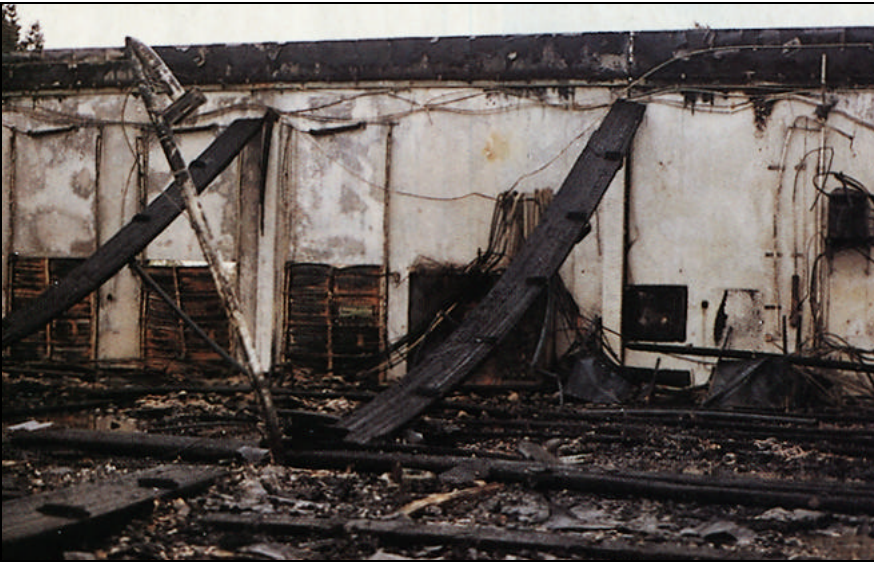
All that remained of the roof system was the middle one-third cross section of the laminated girders. The steel pipe columns buckled, allowing the roof to collapse. The girders pulled loose from the pi-

Interior view of the building shows the extreme damage caused by the fire. Little remained of the plywood roof system except for the glue-laminated girders. Here two collapsed girders are leaning on the tilt-up wall panels. The steel pipe columns supporting the girders buckled in the intense heat. One such column appears in the left side of the picture.

lasters and were leaning against the tilt-up walls.

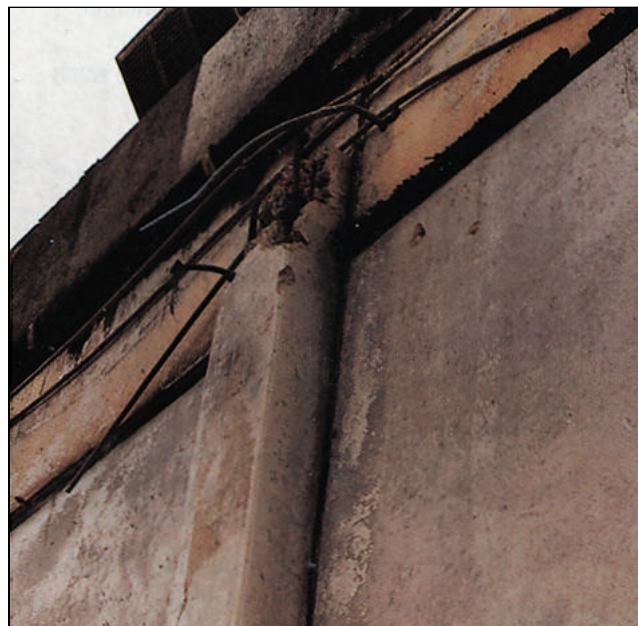
View of the top of a concrete pilaster shows where a girder pulled away from the pilaster before collapsing.
