Contractors can evaluate the potential for thermal cracking that is caused by rapid concrete strength gain in bridge deck repairs

Predicting Thermal Cracking in Bridge Deck Repairs

By John M. Simpson and Edwin G. Burdette

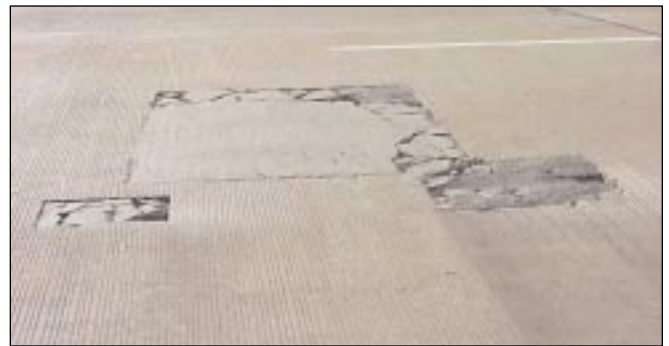
Above: A typical restrained deck repair patch has cracked and is marked for replacement. Left: The construction crew places a repair patch on a bridge deck.

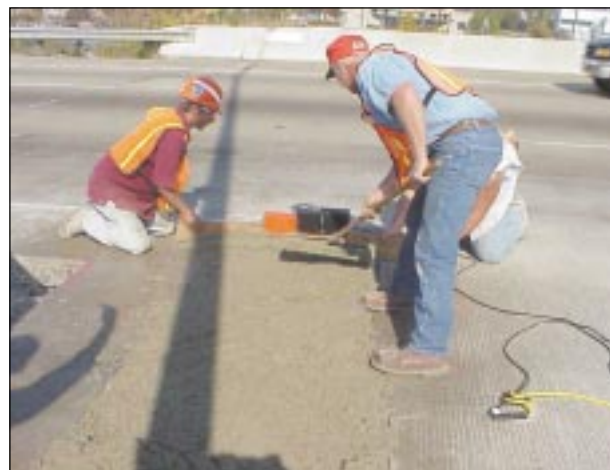
The patching crew is finishing a repair patch. By using the results of this study, contractors can reasonably predict the thermal cracking potential of deck repairs.

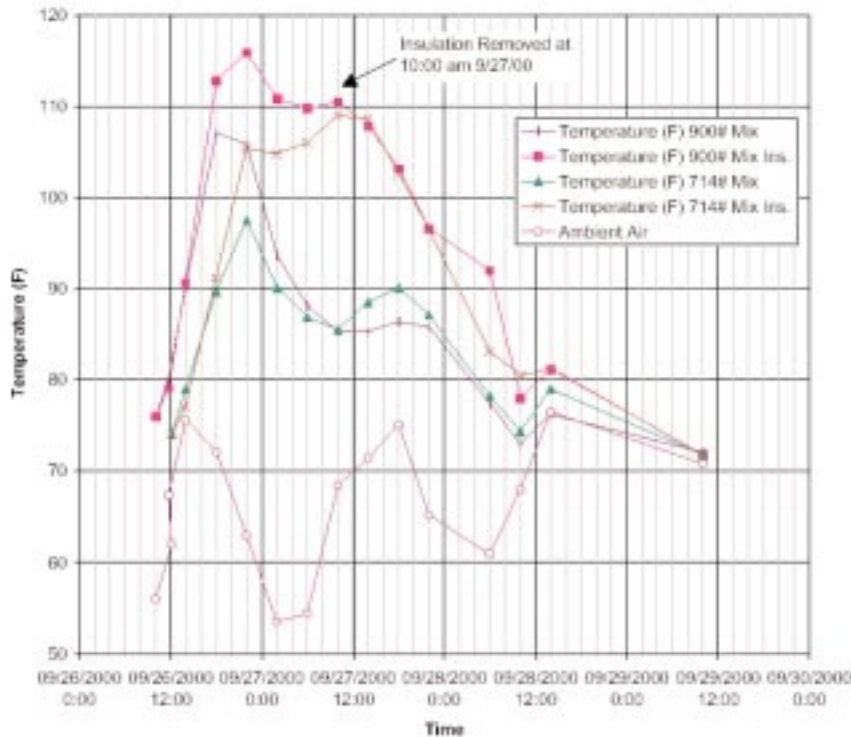
Concrete test blocks—temperature vs. time

Following the cracking failure of additional bridge deck repairs, in September 2000 a study was conducted to determine the temperature change in the concrete mixes used in the concrete repairs. Four concrete test blocks were cast for this study using the approved project design mixes. Each block measured approximately 4 feet square and approximately 1 foot thick. Two of the blocks were cast using the mix containing 714 pounds of cement per yard, and two test blocks were cast using the mix containing 900 pounds per cubic yard. Of each mix, one test block was insulated and one was not. A thermocouple was installed in the middle of each test block to record the internal temperature, and results of the temperature of the air and the blocks were recorded for several days (see the graph to the left).

of a significant portion of the concrete pours and weather conditions. The maximum temperature differential for each test block can be calculated, and the model (see theoretical model, p. 70) can predict reasonable conclusions regarding cracking potential in restrained conditions (Table 1).
