# Slaying the Curling Dragon

Careful planning, optimized mix design, attention to detail, and first-rate execution produce an outstanding floor slab

Installation of interior slabs on grade for large distribution centers can be both simple and complex: simple in that slabs are large, open areas, flat and generally free of obstructions; complex in the difficulty of maintaining an aggressive schedule, controlling the placing environment, and ensuring consistency in materials and workmanship. Through careful planning, communication, and attention to detail, the project team for the new Ace Hardware Distribution Facility in Loxley, Ala., installed a high-quality slab at a blistering pace.

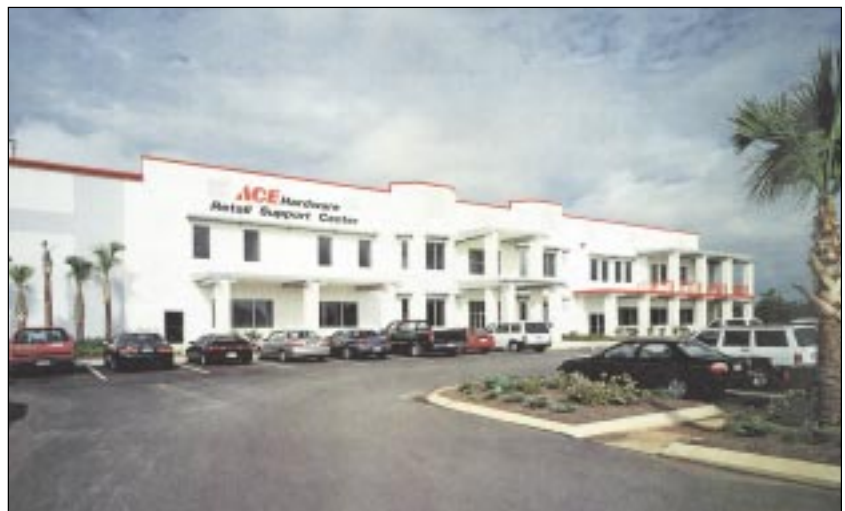
**This distribution center got a high-quality slab through meticulous planning and execution.**

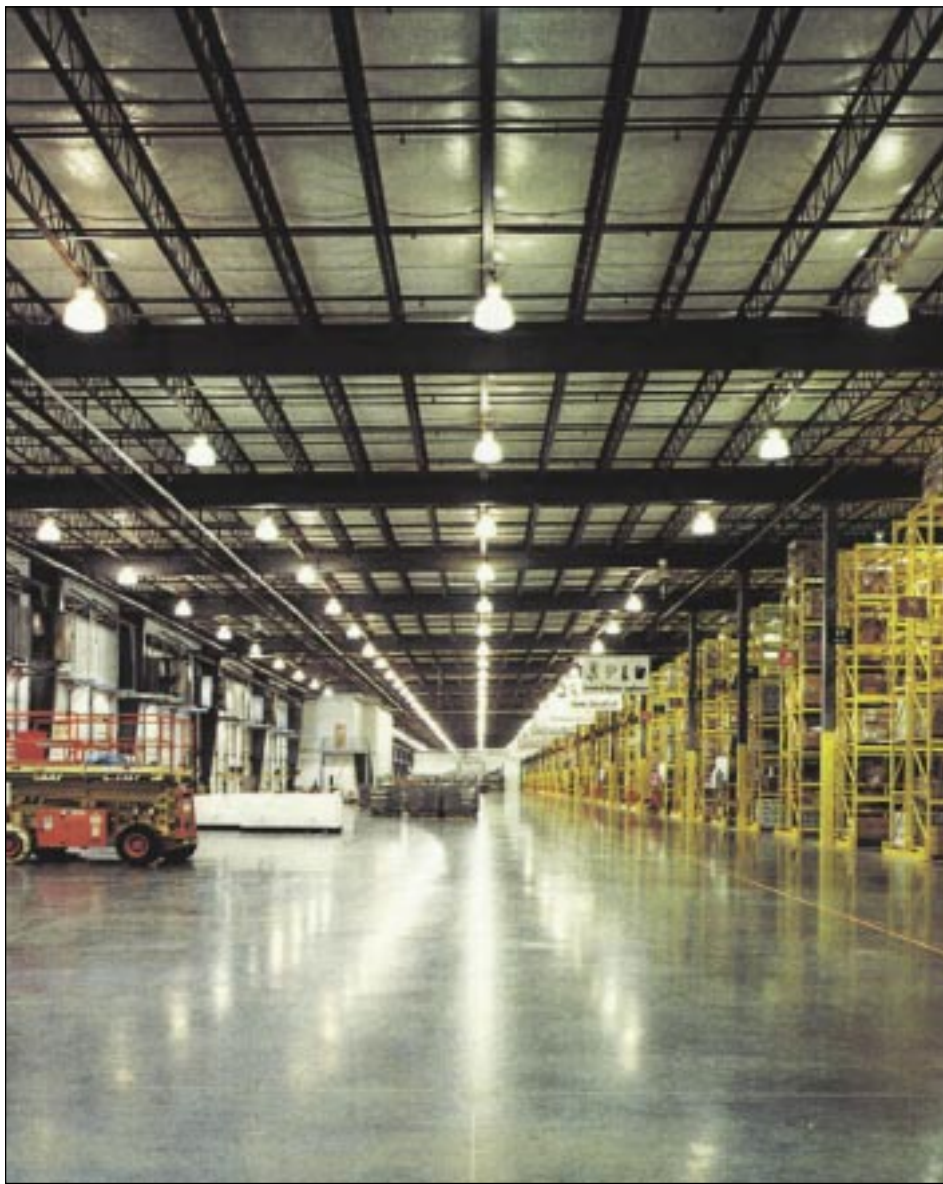
**A year later, the floor is free of cracking and curling.**

Representatives of Ace Hardware, Butler Construction, and W.L. Contracting inspected the warehouse floors after one year. The floors were in excellent condition with no cracking or curling detected over the entire 800,000 square feet. Based on these results, it is apparent that careful planning, optimized mix design, attention to detail, and first-rate execution can produce an outstanding work platform for the life of the facility. An owner can achieve long-term success with an industrial floor by the proper selection of the concrete team, state-of-the-art floor design, detailed planning, and the installation of the complete floor system.
